NAME	Builders Exchange Building			REF. NO. 136
ADDRESS	200 North Main Street			
CITY	Santa Ana	ZIP	92701	ORANGE COUNTY
YEAR BUILT	1928	LOCAL REGISTER CATEGORY: Landmark		
HISTORIC DISTRICT	Downtown Santa Ana	NEIGHBORHOOD	N/A	
NATIONAL REGISTER CRITERIA FOR EVALUATION	A, C	NATIONAL REGISTER STATUS CODE	1B

**SURVEY TYPE:** (Intensive, reconnaissance, or other)  
Intensive Survey Update

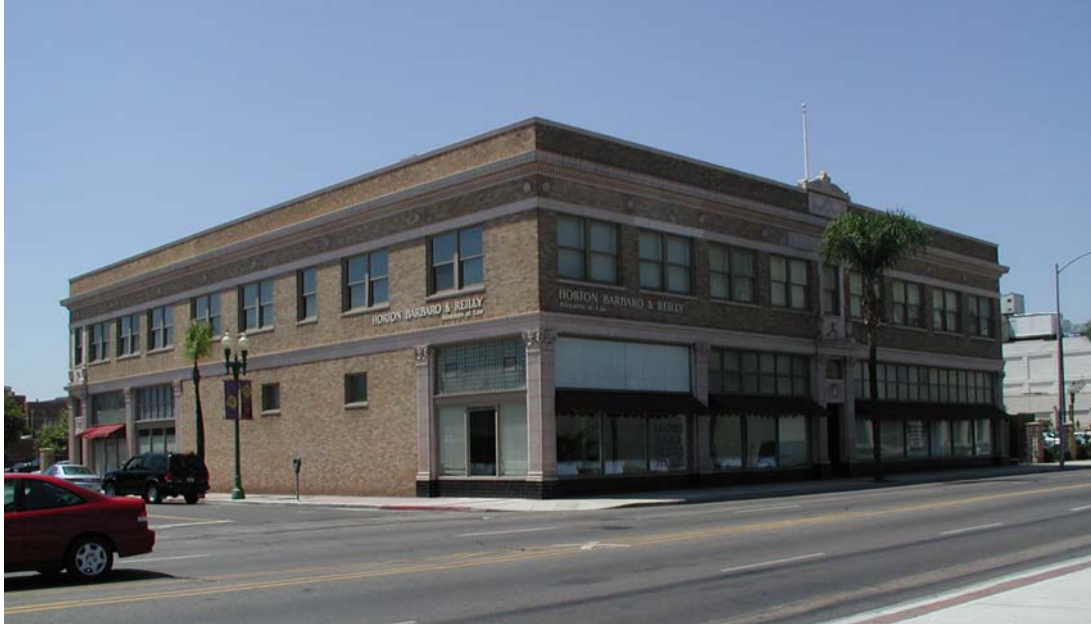
Located on the northwest corner of Main and Second Streets, this is a two-story plus basement commercial building influenced by the Italian Renaissance Revival style. Constructed of steel, reinforced concrete, and brick, the building features architectural ornamentation executed in terracotta. The two public elevations (east and south) are faced with brown brick and banded between stories by a terracotta belt course. Above the second story windows, a second belt course defines the lower edge of an entablature consisting of a brick frieze ornamented with terracotta roundels and a denticulated cornice. A plain parapet tops the cornice, crowned by terracotta coping. At the center of the principal (east elevation), a panel embellished with garlands and swags decorates the parapet with ornamental scrolls and volutes rising above it and a flagpole appearing to emerge from the apex. Fluted piers, with stylized composite capitals, sit on a polished black tile base and divide the lower story of the façade into four bays. The narrow, central bay contains the entrance, highlighted by a shield-embellished panel over the flat-headed opening and by an entablature surmounted by urns. Above a decorated spandrel, the single second story window in this bay features a quoined surround. The name of the building is incised into a terracotta panel centered in the frieze. At street level, two bays to the south of the entry and a double-sized single bay to the north of the entry are similarly composed, with black tile bases, display windows, and transoms. Four pairs of one-over-one double-hung sash windows are located to either side of the central bay on the second story. The south elevation is asymmetrical in organization, with a single bay on the east and two bays on the west duplicating the layout of the façade bays. A second building entrance in the westernmost bay echoes the design of the main entrance. The Builders Exchange Building retains a high degree of exterior integrity, with only minor modifications to the transom glazing apparent.
