NAME	United Automotive Building			REF. NO.	9
ADDRESS	100-110 South Main Street				
CITY	Santa Ana	ZIP	92701	ORANGE COUNTY	
YEAR BUILT	1922	LOCAL REGISTER CATEGORY: Contributive			
HISTORIC DISTRICT	N/A	NEIGHBORHOOD	NA		
NATIONAL REGISTER CRITERIA FOR EVALUATION	A, C	NATIONAL REGISTER STATUS CODE	5S1

ARCHITECTURAL STYLE: Other: One- or Two-Story Brick Commercial

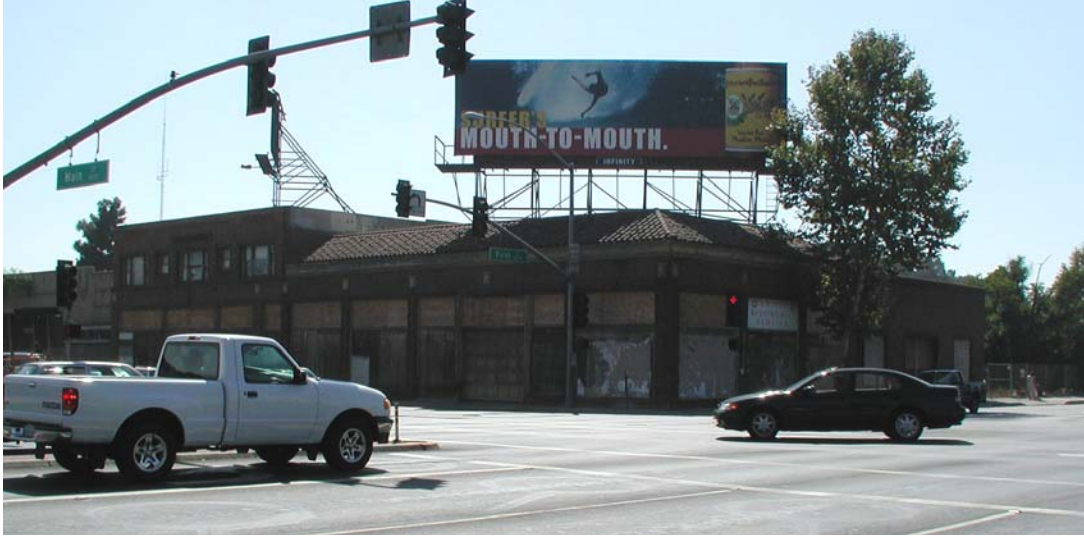
Located on the southwest corner of Main and First Streets, this is a one and two-story commercial building with elements taken from the Spanish Colonial Revival style. Visually, this masonry building with exteriors of dark brown brick consists of three sections. At the corner, a tiled, hip roof tops a one-story section. Piers with cast stone plaques for capitals divide the north (First Street) elevation into three bays and the east (Main Street) elevation into five bays. As of 2001, all of these bays have been boarded up; older photographs show display windows banded by transoms with spindle grilles or *rejas*. To the south, on Main Street, a two-story section is flat-roofed and divided into three bays. The ground floor bays are similar to those on the corner and are also boarded up. Three second-floor tripartite windows are set off by friezes of patterned brickwork above and below them. To the west, on First Street, a one-story section is flat-roofed and is divided into three bays. The plainest of the three parts of the building, this section contains a central vehicular opening with a glazed and paneled door flanked by large, square windows, now enclosed by cement block. Two large billboards have been placed on the roof of the building.

Character-defining exterior features of the United Automotive Building, which should be preserved, include but may not be limited to: exterior materials and finishes, including brown brick and decorative brickwork; bay divisions and storefront configuration; hipped tile roof; original fenestration where extant; architectural detailing such as piers and cast stone ornament; and transoms and grilles, if extant.
