NAME	Commercial Building			REF. NO. 235
ADDRESS	309 West Third Street			
CITY	Santa Ana	ZIP	92701	ORANGE COUNTY
YEAR BUILT	1932	LOCAL REGISTER CATEGORY: Contributive		
HISTORIC DISTRICT	Downtown Santa Ana	NEIGHBORHOOD		
NATIONAL REGISTER CRITERIA FOR EVALUATION	C	NATIONAL REGISTER STATUS CODE	1D

ARCHITECTURAL STYLE: Mission/Spanish Colonial Revival

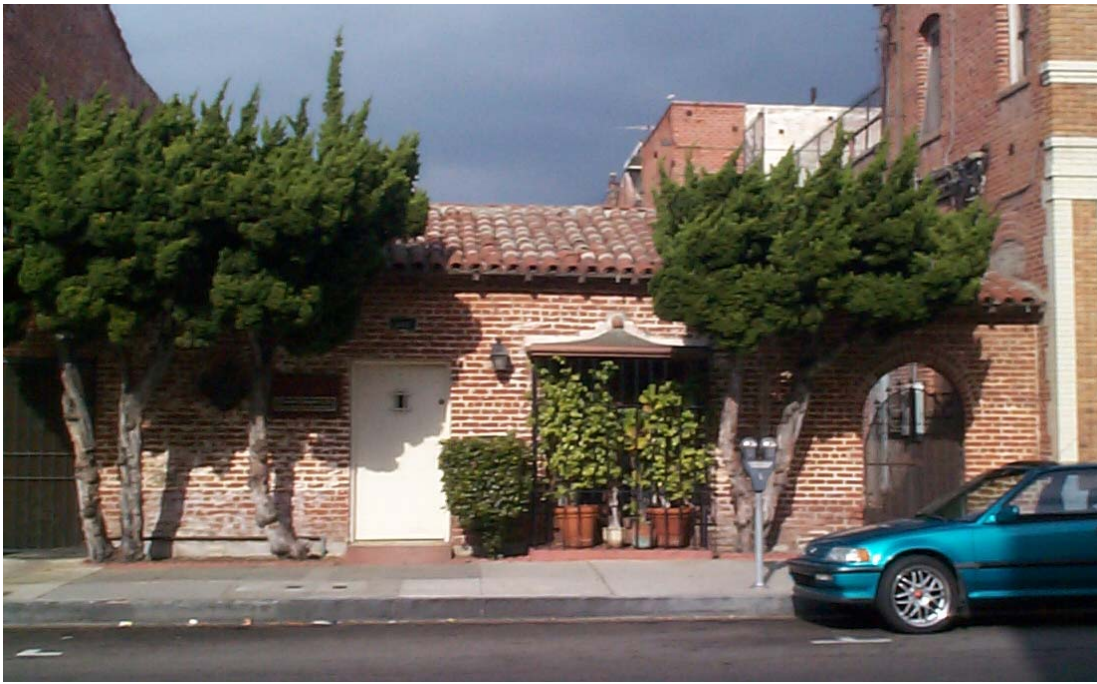
This small, one-story building is located on the north side of West Third Street between Broadway and Birch Streets. Commercial in use, it is a Spanish Colonial Revival style building of brick construction, and has a wood-framed, side gable roof clad in clay tile. The wooden entrance door is flanked on the east by a set of wood French doors with metal hood that would open onto the sidewalk except for the wrought iron bars that screen them from the street. To the west of the entrance door is a small wood framed quatrefoil window. Although the building is freestanding, the main (south) façade wall extends to connect with the building immediately to the east. An arched opening provides access to the open space behind the building.

Character-defining exterior features of this building which should be preserved include, but are not limited to: brick walls; side-gable roof; red clay tile roof cladding; wood bracketed roof overhang; wrought iron detailing such as the east window grille and hood and the entry lantern; "caged" French doors; quatrefoil west window; and the arched opening in the east wing wall.
