| NAME | Otis Building | | | REF. NO. | 187 |
| ADDRESS | 101 West Fourth Street | | | | |

ARCHITECTURAL STYLE: Renaissance (originally built as a Queen Anne in 1889)

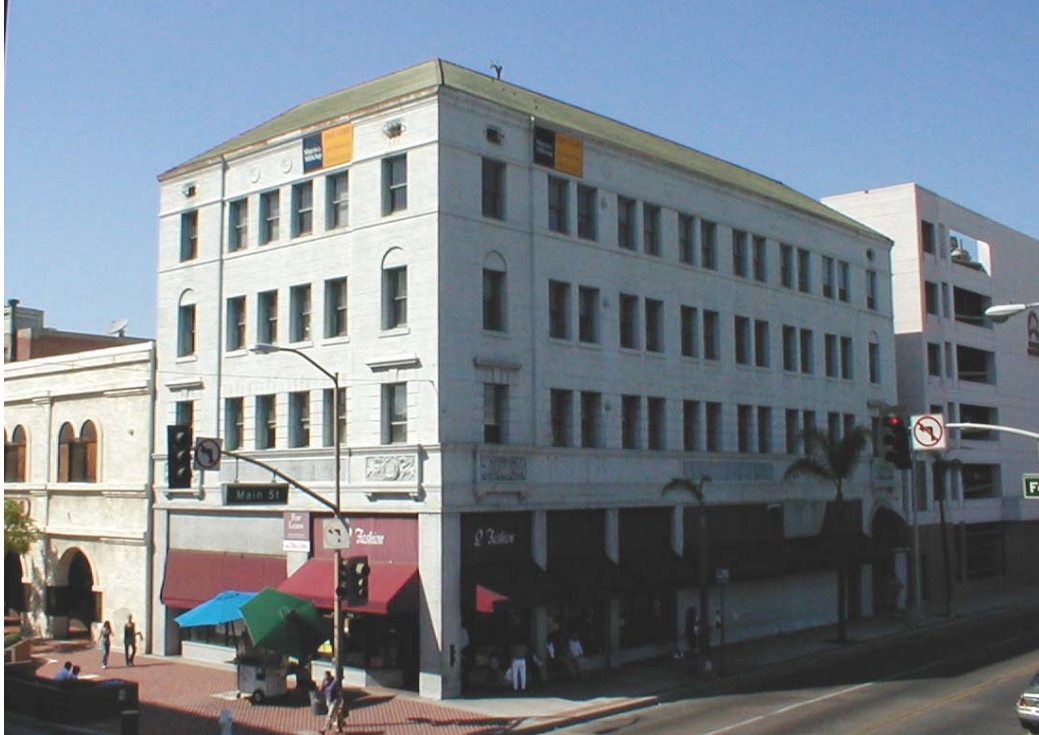
This rectangular shaped four-story retail and office building has a façade of brick with coursed smooth ashlar. The storefronts are 1950's commercial on the first story with deep bays flanked by display windows. The upper façade is of a Renaissance style with simplified elements. Two ornate cartouches are located beneath the second story and each level has a different articulation. Six double hung windows are vertically segmented in three divisions and the building has three upper floors of which the topmost is delineated by a simple belt course. Two small square attic windows flank decorative medallions on the upper level. A mansard roof of asphalt shingle caps the building.
