NAME	Yale Apartments			REF. NO.	101
ADDRESS	1007-1009 North Broadway				
CITY	Santa Ana	ZIP	92701	ORANGE COUNTY	
YEAR BUILT	1928	LOCAL REGISTER CATEGORY: Contributive			
HISTORIC DISTRICT		NEIGHBORHOOD	Midtown		
NATIONAL REGISTER CRITERIA FOR EVALUATION	C	NATIONAL REGISTER STATUS CODE	5D1

ARCHITECTURAL STYLE: Mission/Spanish Colonial Revival

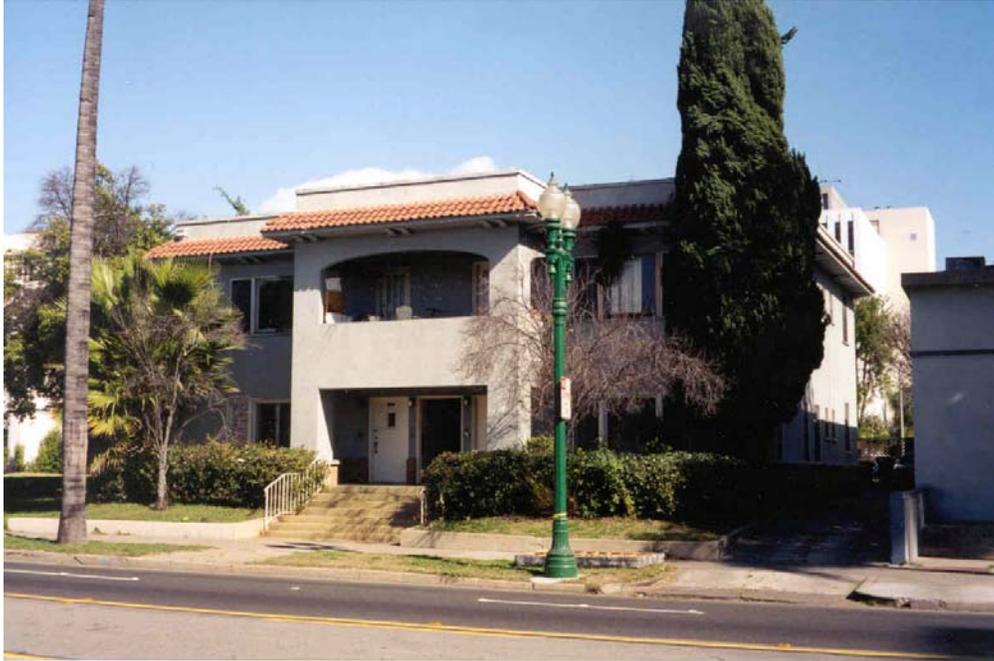
This two story, rectangular fourplex apartment building is located on the east side of North Broadway between 10th and Washington Streets. The building has a flat roof with a parapet, stucco siding, and aluminum framed picture windows on the front elevation. Side elevation windows appear to be intact wood sash. Brick facing accents the façade beneath the lower level windowsills. Symmetrical in composition, the three bay façade is dominated by a projecting two story front porch in the center. On the first floor, the porch contains the building entries within a flat-headed recess while a flattened arch opening frames a balcony on the second floor. A pent-roof clad in red clay tile, with decorative paired brackets punctuating the boxed soffit, wraps the façade and side elevations. The building has been altered by the removal of the original front windows and their replacement with aluminum sash picture windows.
