NAME	Commercial Building			REF. NO. 235
ADDRESS	309 West Third Street			
CITY	Santa Ana	ZIP	92701	ORANGE COUNTY
YEAR BUILT	1932	LOCAL REGISTER CATEGORY: Contributive		
HISTORIC DISTRICT	Downtown Santa Ana	NEIGHBORHOOD		
NATIONAL REGISTER CRITERIA FOR EVALUATION	C	NATIONAL REGISTER STATUS CODE	1D

**ARCHITECTURAL STYLE:** Mission/Spanish Colonial Revival

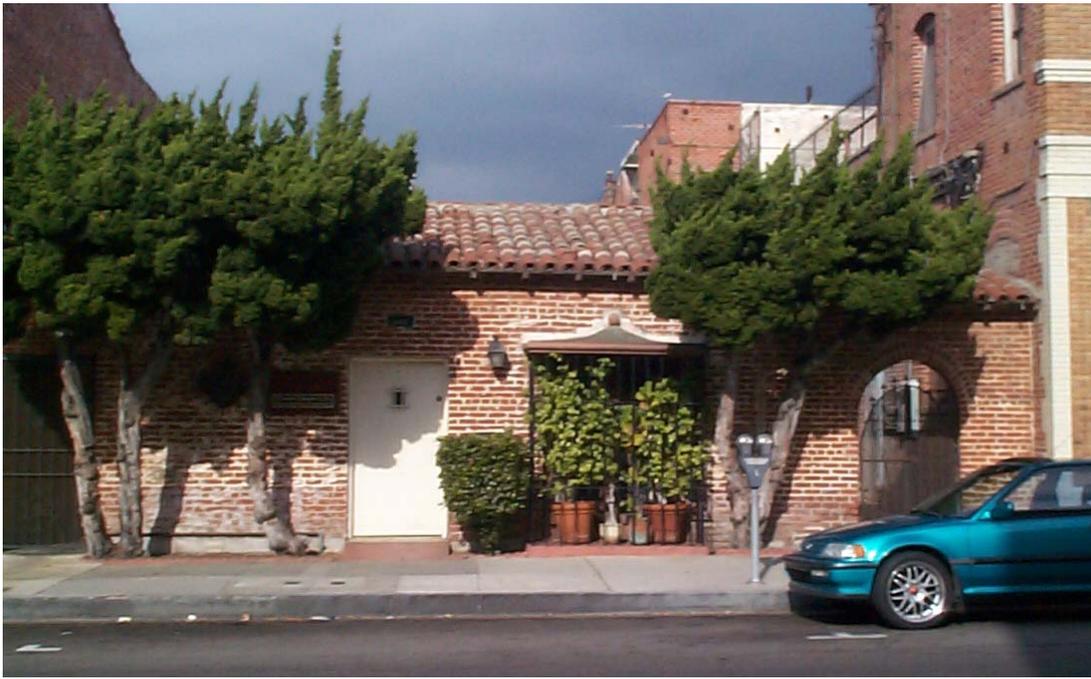
This small, one-story building is located on the north side of West Third Street between Broadway and Birch Streets. Commercial in use, it is a Spanish Colonial Revival style building of brick construction, and has a wood-framed, side gable roof clad in clay tile. The wooden entrance door is flanked on the east by a set of wood French doors with metal hood that would open onto the sidewalk except for the wrought iron bars that screen them from the street. To the west of the entrance door is a small wood framed quatrefoil window. Although the building is freestanding, the main (south) façade wall extends to connect with the building immediately to the east. An arched opening provides access to the open space behind the building.

Character-defining exterior features of this building which should be preserved include, but are not limited to: brick walls; side-gable roof; red clay tile roof cladding; wood bracketed roof overhang; wrought iron detailing such as the east window grille and hood and the entry lantern; "caged" French doors; quatrefoil west window; and the arched opening in the east wing wall.
