NAME	Automobile Club of Southern California			REF. NO. 74
ADDRESS	717-719 North Main Street			
CITY	Santa Ana	ZIP	92701	ORANGE COUNTY
YEAR BUILT	1930	LOCAL REGISTER CATEGORY: Contributive		
HISTORIC DISTRICT	N/A	NEIGHBORHOOD	French Park	
NATIONAL REGISTER CRITERIA FOR EVALUATION	A, C	NATIONAL REGISTER STATUS CODE	5S1

SURVEY TYPE: (Intensive, reconnaissance, or other)
Intensive Survey Update

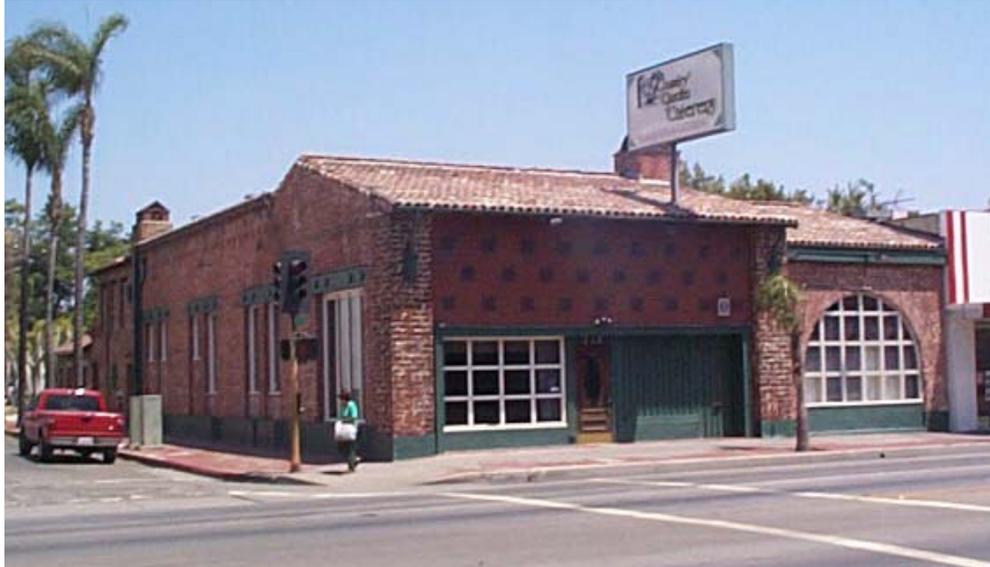
Located on the southeast corner of Main and Eighth Streets, this is a one and two-story building in the Spanish Colonial Revival style. Of brick construction, the building is topped, on the street elevations, by a gabled roof covered in red clay tiles. Small cupolas mark the transitions on both elevations between roof levels. Shaped rafter tails are visible in the eaves. The primary elevation faces west and is asymmetrical in composition. A large bay recessed between plain piers occupies the north two thirds of the façade and contains a large, twelve-light display window, an entry, and a wood paneled section, all set beneath a wall decorated in a checkerboard pattern. At the south end of the façade, a large, arched, multi-light window set atop a solid base fills a single bay. The north elevation features an irregular arrangement of single and double windows, either fixed sash or casement in type, topped by heavy, wooden headers. A row of bricks set at an angle projects from the wall at the eaves in a cornice decoration. At the east end, an arched entry and an "X" patterned grille are notable features. Alterations include the modification of the west storefront, including the enclosure of a central vehicular opening, application of tile to create the checkerboard design, re-glazing of some windows, and based on the condition of the bricks, removal of stucco from the west elevation.
