NAME	Gilmaker Auto Agency Building			REF. NO. 240
ADDRESS	217-221 North Broadway			
CITY	Santa Ana	ZIP	92701	ORANGE COUNTY
YEAR BUILT	1931	LOCAL REGISTER CATEGORY: Contributive		
HISTORIC DISTRICT	Downtown Santa Ana	NEIGHBORHOOD		
NATIONAL REGISTER CRITERIA FOR EVALUATION	C	NATIONAL REGISTER STATUS CODE	1D

**ARCHITECTURAL STYLE:** Mission/Spanish Colonial Revival

Intensive Survey Update

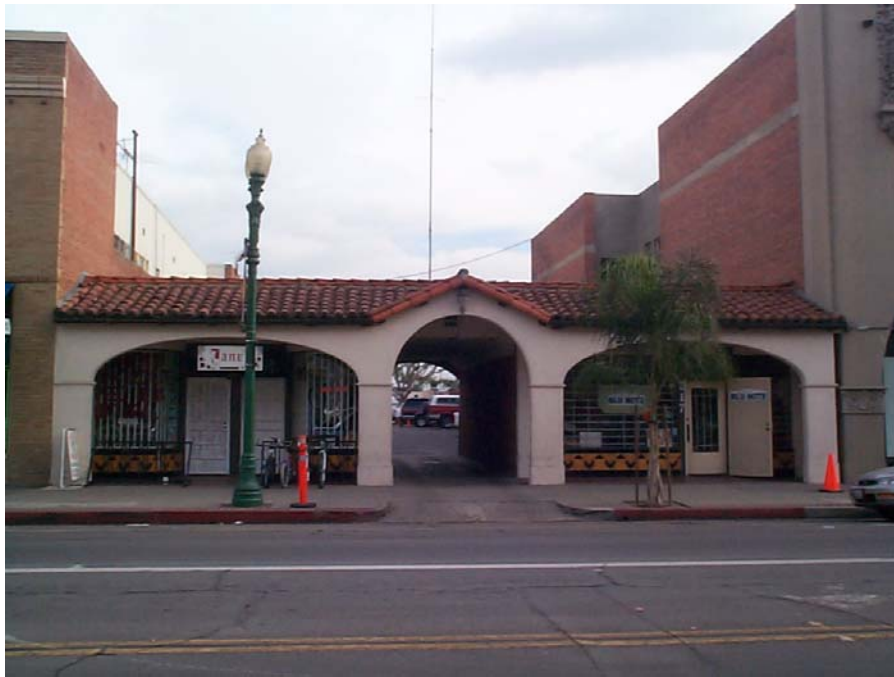
This Spanish Colonial Revival style building is located on the east side of N. Broadway between 2nd and 3rd Streets. One story in height, it is built of brick with a stucco exterior, and has a tiled side gable roof. Only about 30 feet deep, the building consists of three bays: a central drive-through passage topped by a front gable roof flanked on either side by storefronts recessed beneath the side gable roof. A round-headed arch defines the auto passage while broad elliptical arches form a shallow arcade in front of the storefronts. Impost moldings detail each archway. Orange and black glazed tile in a zig-zag motif decorate the bulkheads. The storefronts have newer plate glass display windows, and the entrance doors are recessed with arched transoms. Rear elevation windows are one-over-one double-hung wood sash. The building appears to be in good condition, and retains a high degree of integrity of materials, design and workmanship.

Character-defining exterior features of this building which should be preserved include, but are not limited to: stuccoed exterior; side gable roof with central front gable; red clay tile roof cladding; three bay arcade; impost moldings; storefront configuration and materials where original (tile bulkeads, wood and glass door); and central pass-through.

The Gilmaker Auto Agency Building is architecturally significant as a good, intact example of the Spanish Colonial Revival style in downtown Santa Ana. The stucco finish, tile roof, and arches are all typical of the style, and the building retains good integrity.
